Nor848A Acoustic camera

Pinpointing Low Level Sanitary Noise in Apartment Building

Jørgen Grythe, Norsonic AS

Measurements in apartment building in Oslo, Norway, April 2015

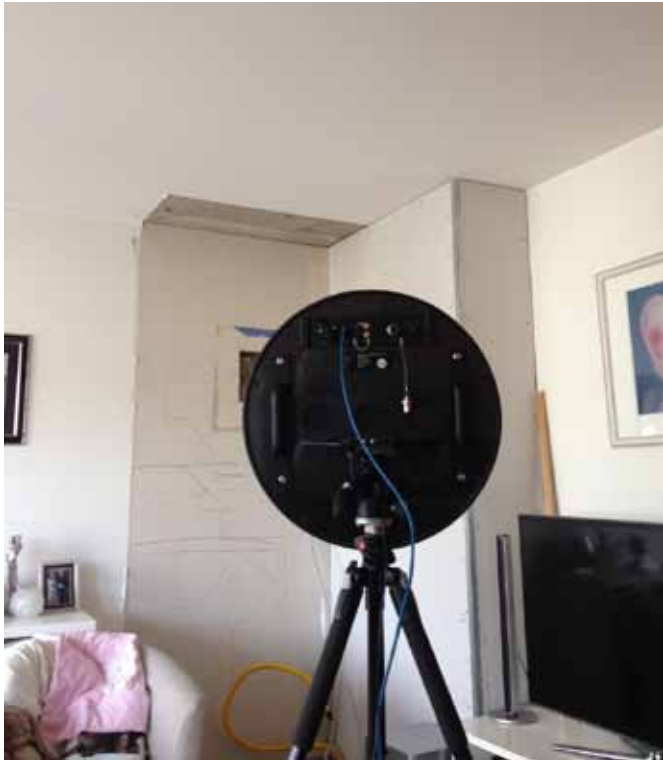
The 40 cm Nor848A-0.4 acoustic camera with 128 microphones was used for the measurements. Although the external battery pack could have been used for extra mobility, the easy access to power outlets meant that the camera could be plugged in directly in the wall outlet in the different measurement rooms.

The light weight and small size of the array ensured easy portability and also great flexibility in measurement posi-

tions. The camera could be set up on the tripod, but also positioned on the floor, in a bed, on a couch or just hold it by hand all based on what part of the room one would like to listen to and get the acoustic image from. The 40 cm camera proved to be very handy in a measurement situation where it was not given beforehand exactly where the source of interest was positioned. In that way the camera could easily be used to scan around different parts of different rooms.

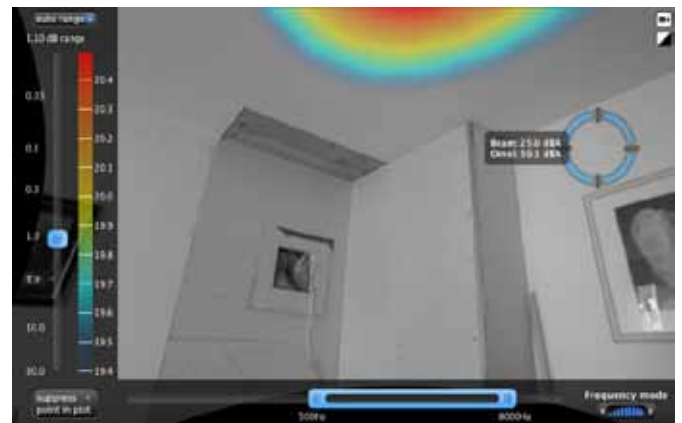
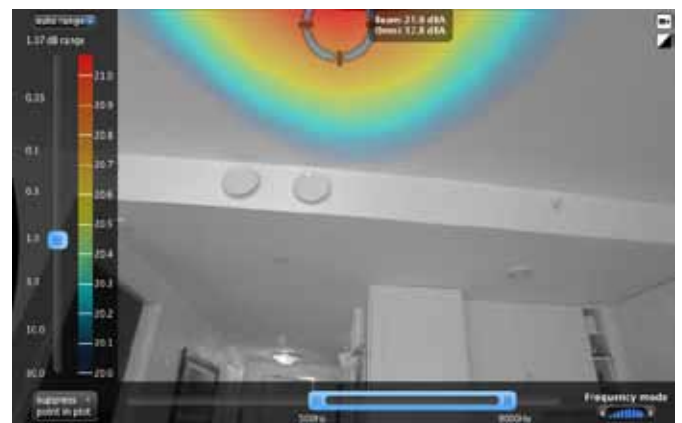
The first recording of the flushing event did not produce the desired result. The source colouring was on a wall adjacent to the embedded pipes, but no pipes were in that part of the building, and it was impossible that the noise could originate from that position. By looking at the recording and listening to the center of the colouring on the video, one could quickly realise what was happening. Because of the very low noise levels, the camera was picking up the strongest source in the room, which in this case was a reflection on the wall from the noise of the cooling fan of the Macbook that was being used for the recordings. This was solved by placing the Macbook in a different room and closing the door. The ethernet cable from Macbook to the acoustic camera was small enough in diameter that the

person doing the recordings could sit virtually anywhere he or she pleased, as long as the cable was long enough. On the second try one could clearly hear the sanitary noise for a period of around 8 to 10 seconds. When filming at the location of the encased pipes in the corner of the living room, the acoustic camera did not pick up any energy at that position, but rather the colouring was upwards towards the roof and outside the field of view of the camera at that measurement position. This was a very strong indication that the origin of the noise was in fact located somewhere else, and the camera was directed accordingly for the subsequent measurements.
