Nor848A Acoustic camera

Finding Acoustical Weak Points in Room Dividing Modular Walls

Jørgen Grythe, Norsonic AS

Measurements in a conference hotel in Trondheim, Norway, November 2014

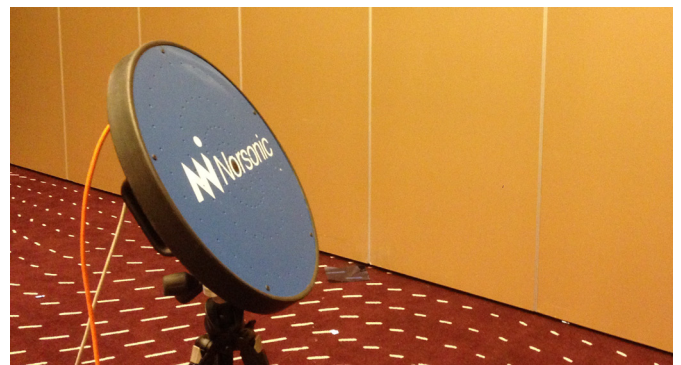
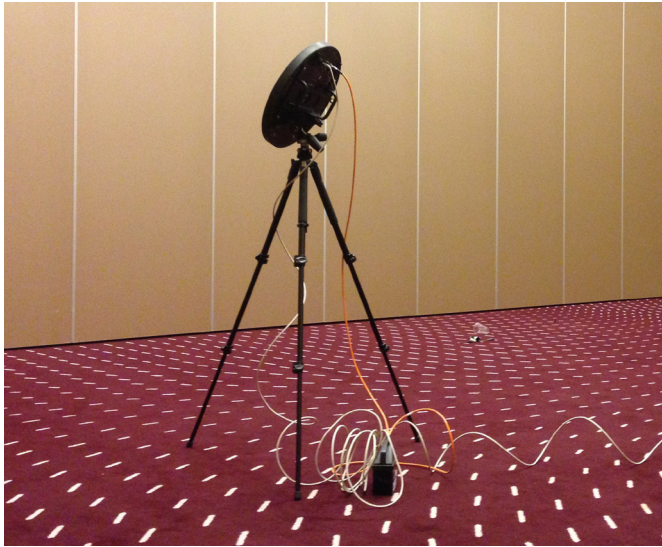
The measurements were conducted with the Nor848-0.4 40 cm and 128 element acoustic camera. The camera was plugged into an external battery pack for easy transportation and mobility. The measurement procedure consisted of choosing two adjacent rooms divided by a modular wall of interest. One of the rooms was chosen to act as receiving room, where the acoustic camera was positioned. A noise source and omnidirectional loudspeaker generating white noise at high volume was positioned in the source room. The speaker was placed in one of the corners of the room furthest away from the dividing wall, in order to achieve as diffuse source noise field as possible.

Due to the large size of the modular walls, the camera was pointed to different areas of the walls, and several measurements were made. The individual measurements could then be examined further in post-processing analysis. Due to the source being used at high volume in the sending room, cracks and gaps in the modular walls would appear as small noise sources at specific location on the walls when recording with the acoustic camera in the receiving room.
