# Nor848A Acoustic camera

## Filming Low-Frequency Structure Born Noise With Acoustic Camera

### Measurements in apartment building Oslo, Norway, September 2015

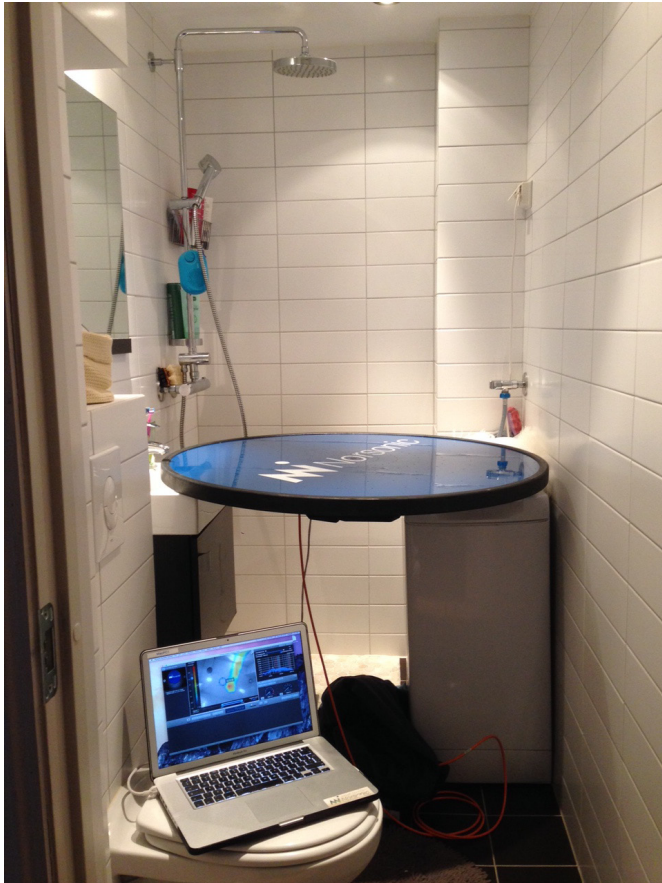
The Norsonic Nor848A-10 1.0m acoustic camera with 256 microphones was used for the recordings. The camera was plugged into an external battery pack for easy transportation and mobility. Measurements were made both in the attic at

the source location, and also in the bedroom and bathroom of one of the apartments three floors below. The Nor848A-10 was chosen for the recordings over the more compact and mobile 40 cm and 128 microphone Nor848A-4, mainly due to the low-frequency nature of the noise. An array that is

larger in size will have better resolution for all frequencies, and will also be able to go lower in frequency content. Even though the Nor848A-10 has a diameter of 1.0 meter, it weighs in at only 11 kg with tripod mounting brackets, and could easily be mounted on a tripod for inspection of the air fan in the attic, or laid down on the floor, or a bed or similar for inspection of the roof in the bedroom and bathroom of the apartment.

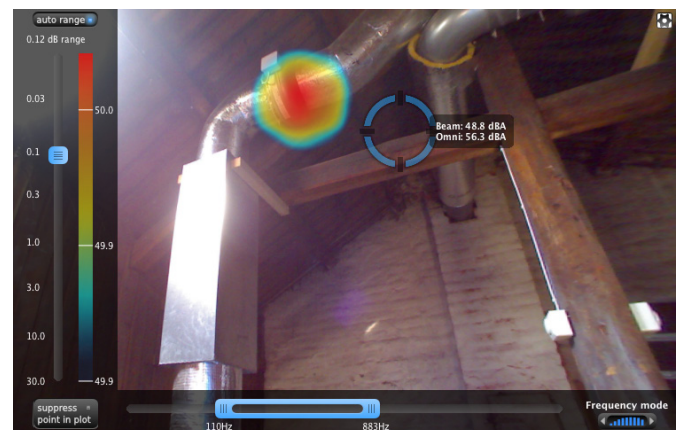
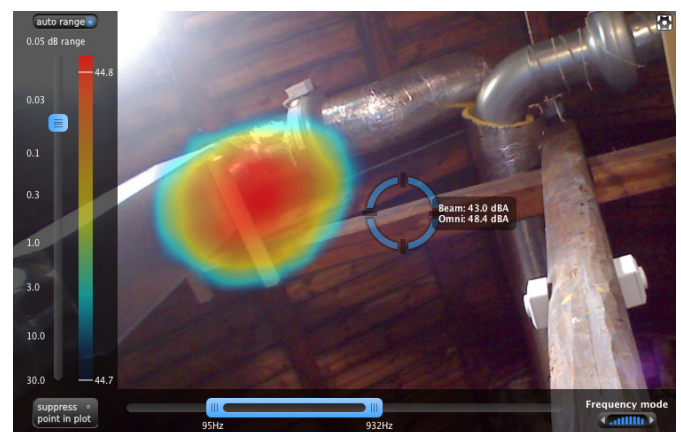
Looking at the recordings from the attic, it was clear that the intake fan was the main culprit having a dominating fundamental frequency at 200 Hz. Also several harmonics of the fundamental frequency could be seen in the frequency spectrum. Since the distance between the attic and the measurement apartment was several floors, and

the sound pressure level of the fan noise in the attic was around 40-50 dB, it would have been impossible for the noise in the apartment to be anything other than structure born noise. By inspecting the pipes it was seen that they were cemented in place to the building structure itself without any form of vibration damping measures in place.

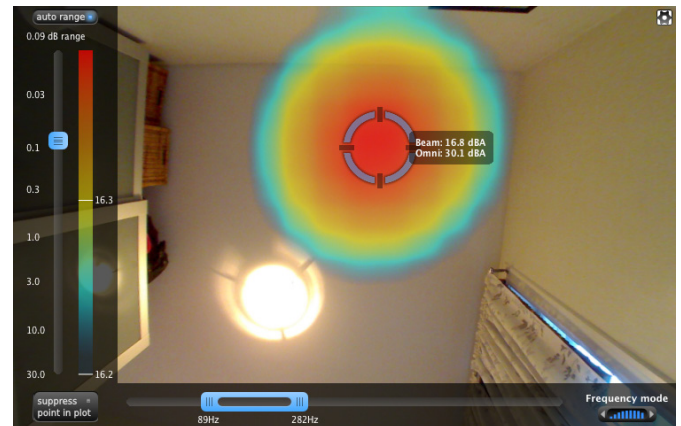
The air flows through the pipes and enters the bathroom in the measurement apartment through an air valve in the roof. By positioning the camera so that the measurement direction is straight up at the roof, it was possible to film the structure born noise and get images as seen below. Also by looking at the frequency spectrum one could see how the frequency content of the obtained noise in the bathroom had the same characteristics as the frequency spectrum in the attic. However now more sub harmonics below 200 Hz were seen in the spectrum as seen from the image below.
