# Norsonic Acoustic Camera

## Using acoustic camera inside caravan car to find squeak and rattle noise

### Measurements in caravan car, Lier, Norway, October 2015

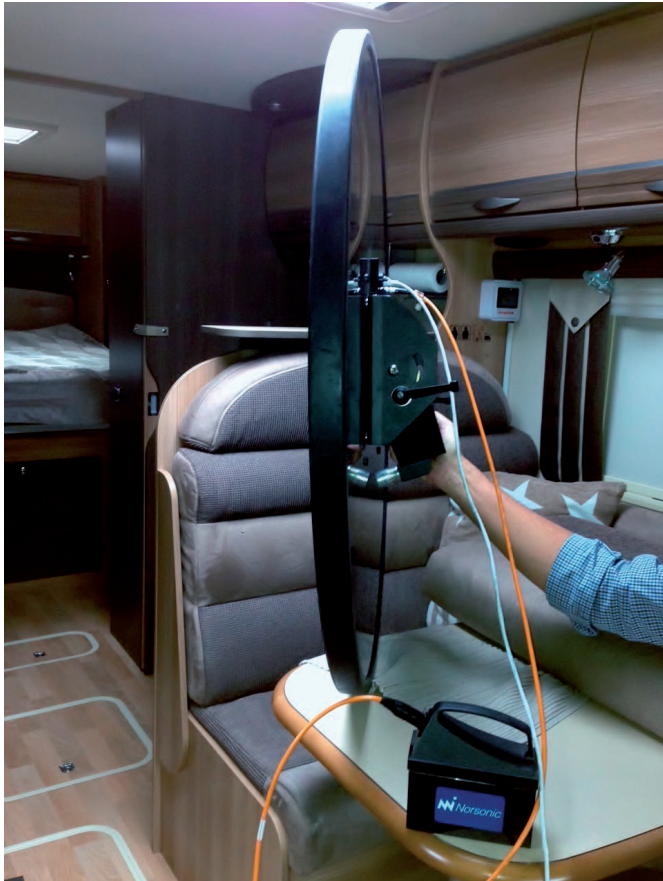
The Norsonic Nor848A-10 1.0m acoustic camera with 256 microphones was used for the recordings. The camera was plugged into an external battery pack for easy transportation and mobility. Although the 40 cm Nor848A-0.4 acoustic camera would have been more mobile, at the time of the measurements it was unavailable. Nevertheless there was more than enough room in the caravan car to use the Nor848A-10.

The measurements were done with one person driving the caravan, and another placing the camera dish on a table and performing the measurements. As the array dish itself weighs in at only 11 kg, it was easy to control it with one arm, and starting and stopping a measurement in the software on the MacBook with the other arm. No tripod was used or needed for the measurements.

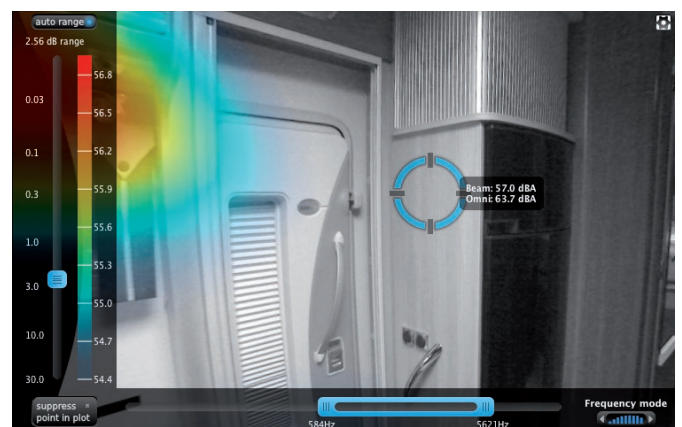
Seen in the image below is the initial result when filming at the fridge in the living compartment of the caravan with the caravan driving and turning, and when the distinct metal rolling sound was heard. As seen from the image there was no indication whatsoever that the sound originated from the fridge in the middle of the picture. Instead the coloring indicated that the sound originated from a different location. Also listening with the virtual microphone could more or less rule out the possibility that the fridge was the source origin. Instead the camera was positioned to aim to the left of the fridge where the coloring indicated a source. The position of the true source was seen more or less

instantly to be inside a cabinet positioned on the wall of the car. This true source location was also confirmed when listening with the virtual microphone on a recording, and even when holding the ear into the cabinet when driving.

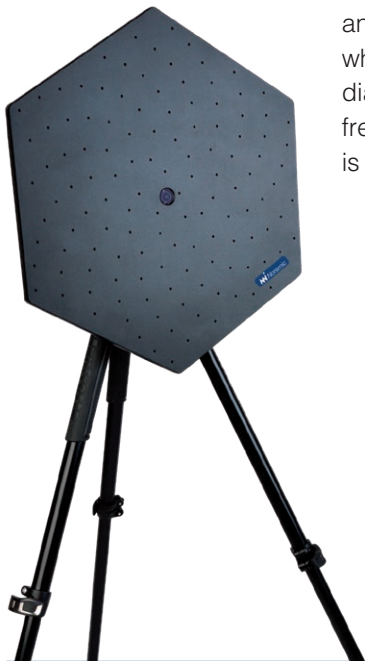
With a single Hextile, the user has a small, portable and lightweight acoustic camera that can be used for a wide range of measurement situations. The Hextile is a USB based acoustic camera, with a single USB cable for both power and data transfer – no extra battery cable needed. The array is made from robust and lightweight aluminium,

has 128 MEMS microphones, and is less than 3 kg in weight while having a maximum diameter of 46 cm. The low frequency limit for the Hextile is 410 Hz.

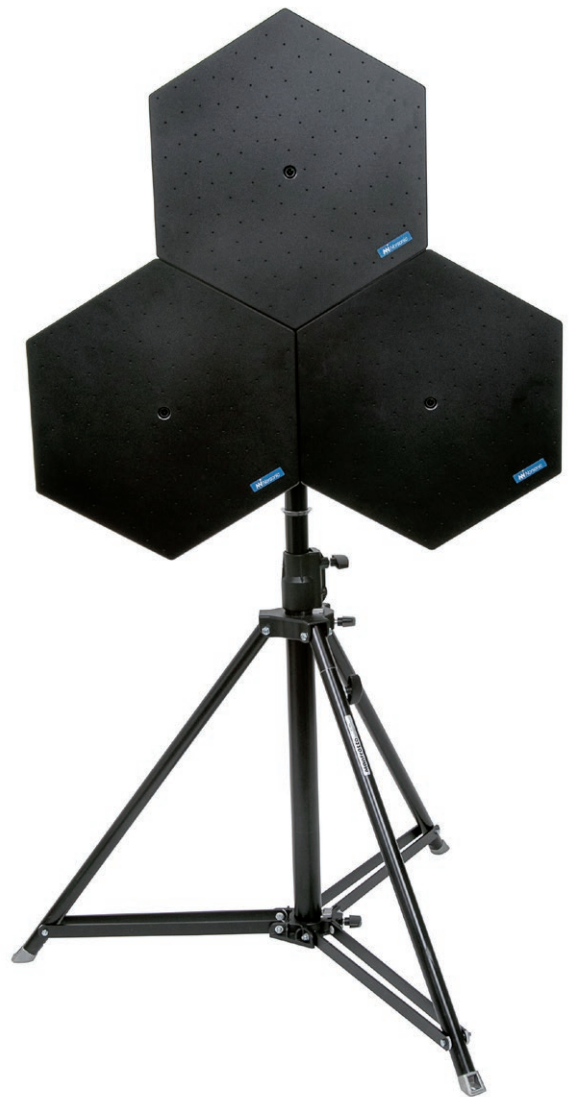
For users that require better resolution both in lower frequencies and overall, three single Hextiles can be combined to a larger Multitile system, consisting of 384 microphones with a maximum diameter of 96 cm. The low frequency limit for the Multitile is 220 Hz.

For special low frequency applications below 1 kHz, it is also possible to utilise the Multitile in the low frequency configuration as the Multitile (LF mode). By placing the individual Hextiles further away, the maximum diameter of the complete array system is increased to 1.46 m, making it ideal for low frequency measurements. The Multitile (LF mode) is for low frequency measurements below 1 kHz, with a lowest frequency limit of 120 Hz.
