# Norsonic Acoustic Camera

## Pinpointing low level sanitary noise in apartment building

### Measurements in apartment building in Oslo, Norway, April 2015

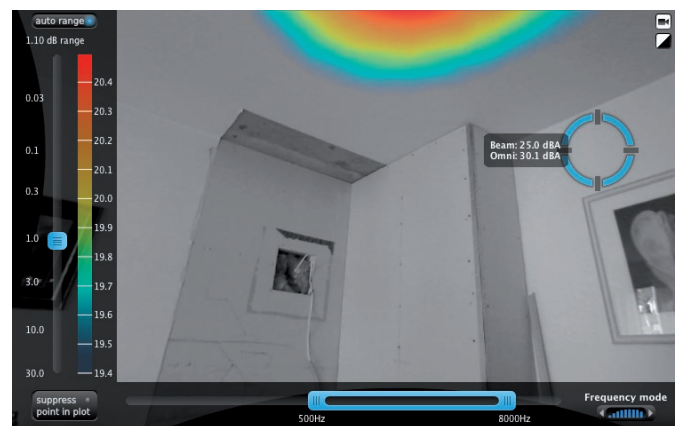
The first recording of the flushing event did not produce the desired result. The source colouring was on a wall adjacent to the embedded pipes, but no pipes were in that part of the building, and it was impossible that the noise could originate from that position. By looking at the recording and listening to the center of the colouring on the video, one could quickly realise what was happening. Because of the very low noise levels, the camera was picking up the strongest source in the room, which in this case was a reflection on the wall from the noise of the cooling fan of the Macbook that was being used for the recordings. This was solved by placing the Macbook in a different room and closing the door. The ethernet cable from Macbook to the acoustic camera was small enough in diameter that the

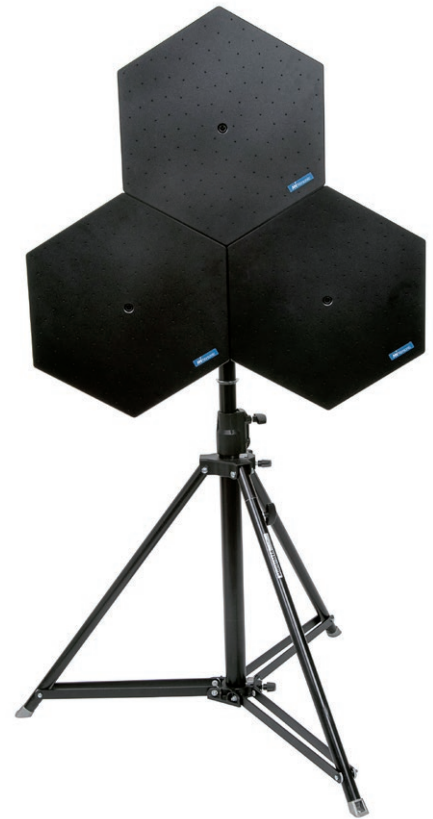
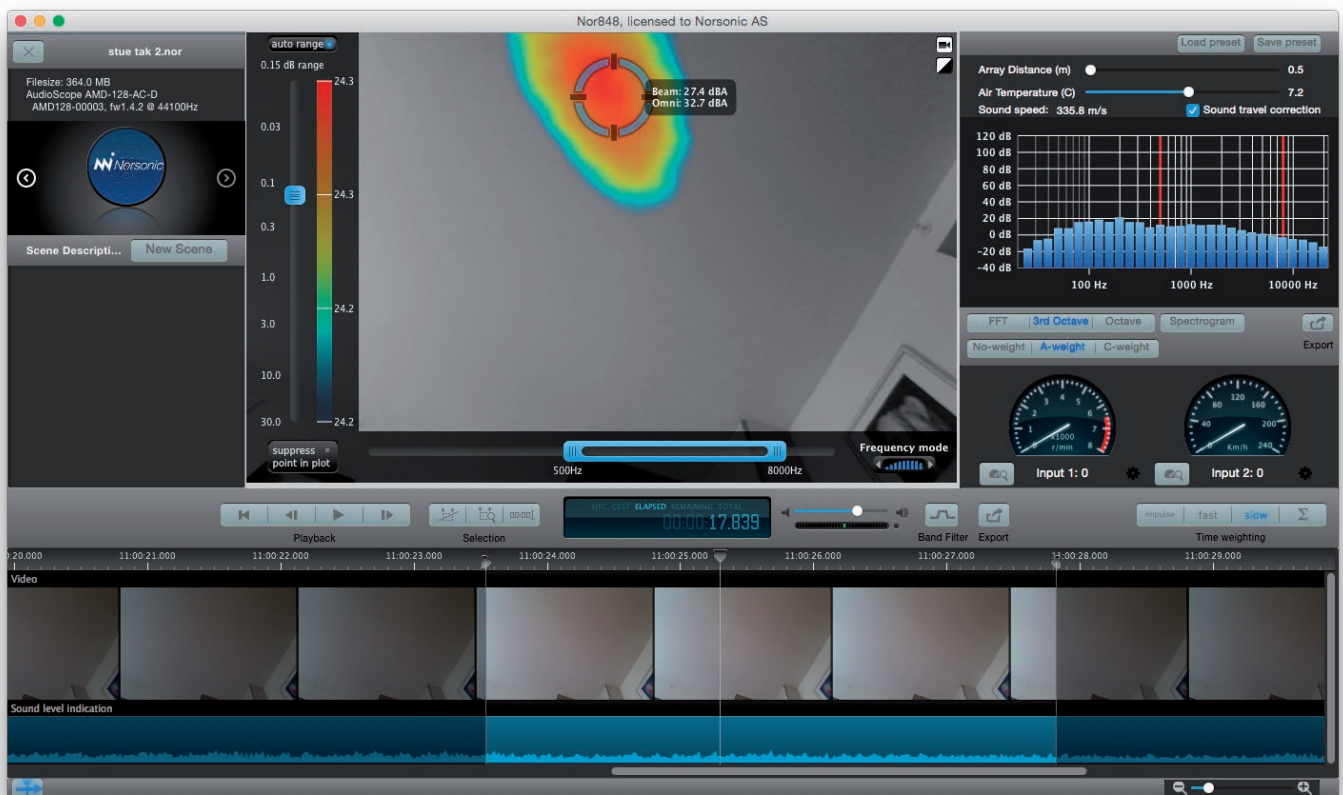
The Norsonic acoustic camera is a module based approach to acoustic camera that gives the user both portability and great resolution for a wide range of measurement situations. The array dish is based on a hexagon shape, given it both its name, and the ability to combine several tiles into larger systems.

With a single Hextile, the user has a small, portable and lightweight acoustic camera that can be used for a wide range of measurement situations. The Hextile is a USB based acoustic camera, with a single USB cable for both power and data transfer – no extra battery cable needed. The array is made from robust and lightweight aluminium, has 128 MEMS microphones, and is less than 3 kg in weight while having a maximum diameter of 46 cm. The low frequency limit for the Hextile is 410 Hz.

For users that require better resolution both in lower frequencies and overall, three single Hextiles can be combined to a larger Multitile system, consisting of 384 microphones with a maximum diameter of 96 cm. The low frequency limit for the Multitile is 220 Hz.

For special low frequency applications below 1 kHz, it is also possible to utilise the Multitile in the low frequency configuration as the Multitile (LF mode). By placing the individual Hextiles further away, the maximum diameter of the complete array system is increased to 1.46 m, making it ideal for low frequency measurements. The Multitile (LF mode) is for low frequency measurements below 1 kHz, with a lowest frequency limit of 120 Hz.
