Nor848A Acoustic camera

Finding Acoustical Weak Points in Room Dividing Modular Walls

Measurements in a conference hotel in Trondheim, Norway

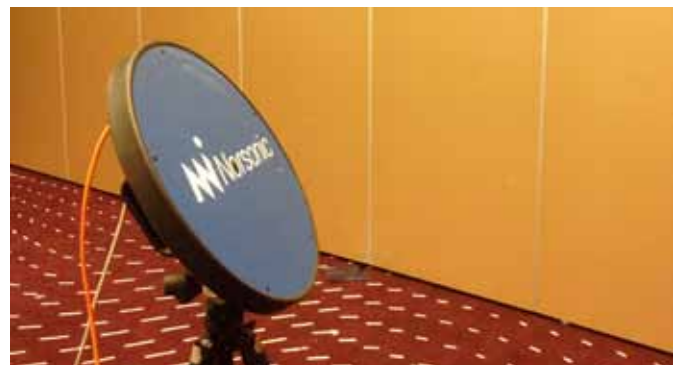
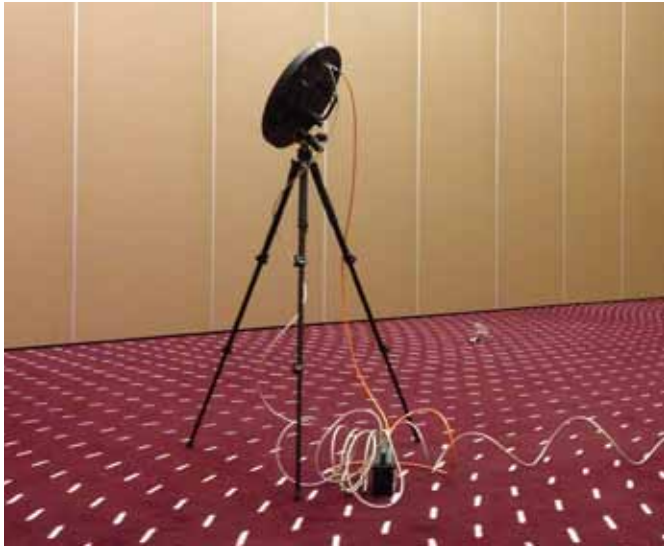
The measurements were conducted with the Nor848-0.4 40 cm and 128 element acoustic camera. The camera was plugged into an external battery pack for easy transportation and mobility. The measurement procedure consisted of choosing two adjacent rooms divided by a modular wall of interest. One of the rooms was chosen to act as receiving room, where the acoustic camera was positioned. A noise source and omnidirectional loudspeaker generating white noise at high volume was positioned in the source room. The speaker was placed in one of the corners of the room furthest away from the dividing wall, in order to achieve as diffuse source noise field as possible.

Due to the large size of the modular walls, the camera was pointed to different areas of the walls, and several measurements were made. The individual measurements could then be examined further in post-processing analysis. Due to the source being used at high volume in the sending room, cracks and gaps in the modular walls would appear as small noise sources at specific location on the walls when recording with the acoustic camera in the receiving room.
